# Tech tips

United States Department of Agriculture  
Forest Service

July 1993

## Helicopter Operations and External Accessories: An Update

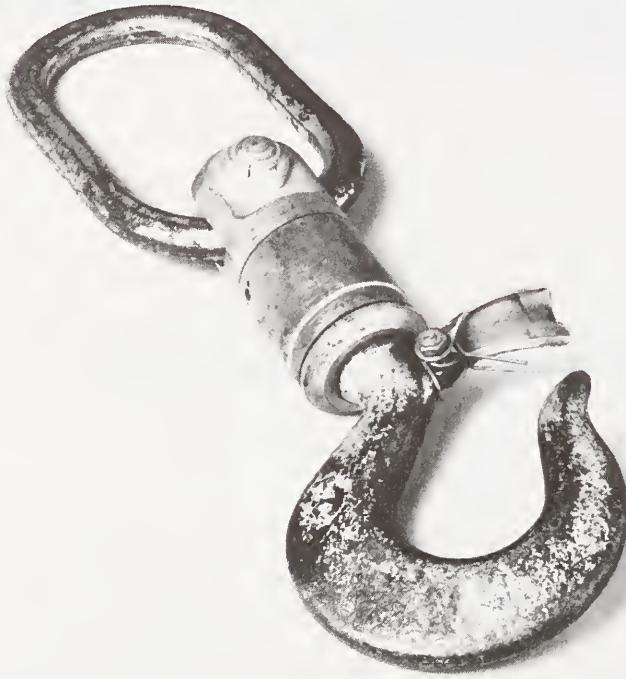
A review of incident reports by San Dimas Technology and Development Center verified field reports of a recurring problem with helicopter leadline hooks. Eighteen per cent of all inadvertent load releases were attributed to gate failures on either swivel or leadline hooks. Such a failure is shown in figure 1.

*Figure 1. Swivel hook with bent gate.*

Safety gates (keepers or latches) that have become bent or distorted no longer help protect a sling load from inadvertently coming off the hook. Usually the latch is bent or distorted by dropping the hook with a ring in it, or by allowing the load to apply a side force to the latch. In any case, the result is a damaged unacceptable latch. The solution is to replace the damaged latch.

The replacement kit nomenclature is "SS-4055 x ton" where x is the hook rating in tons. It includes a new gate, spring, bolt and self-locking nut (all stainless steel) and may be purchased from any Crosby distributor.

suggest that the latches should be: 1) inspected daily when in use, 2) inspected for damage every time they are checked into or out of a cache, and 3) replaced if bent or distorted.
